Kodak DryView
8900 LASER IMAGER

Service Bulletins

Kodak DryView 8900 LASER IMAGER

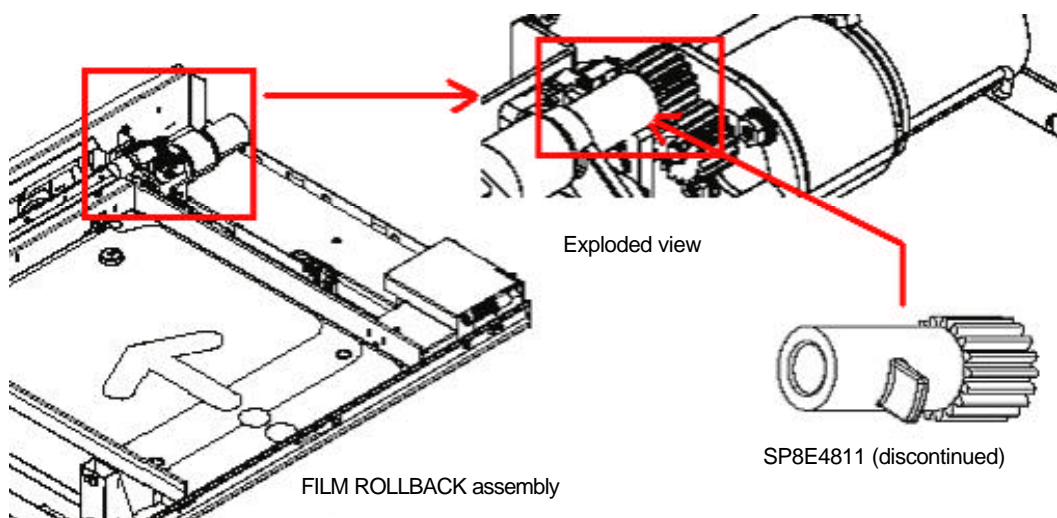
Please be advised that Part Number SP8E4811 has been discontinued and has been replaced with two individual parts.

The 2 individual parts created are seen below. Machine Serial Number effectivity for the use of these new components is unknown. A minimum quantity of 5 each of the new components should be maintained in all field service custody.

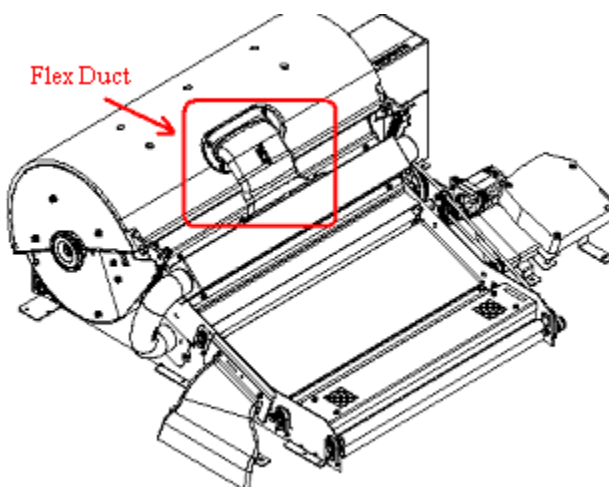
Mechanical design has made a product enhancement to the Air Duct on the Thermal Processor Assembly. The modification increases the airflow through the Processor and assists in removing more of the FAZ from the Thermal Processor assembly. Below is an image of the new Duct.

Machines with S/Ns before 890002670 can be modified to include the Flex Duct. The main components of the new Flex Duct are as follows:
